# Home / Building Inspection Report

Report prepared for: John Doe  
Property address: 123 Main St, Somewhere, NH.  
Date of Inspection: 10/09/2014  
On site start time of inspection: 10:00 A.M.  
On site finish time of inspection: 1:20 P.M.  
Approx. year building constructed: 1910.  
Property type: Two family, wood framed.

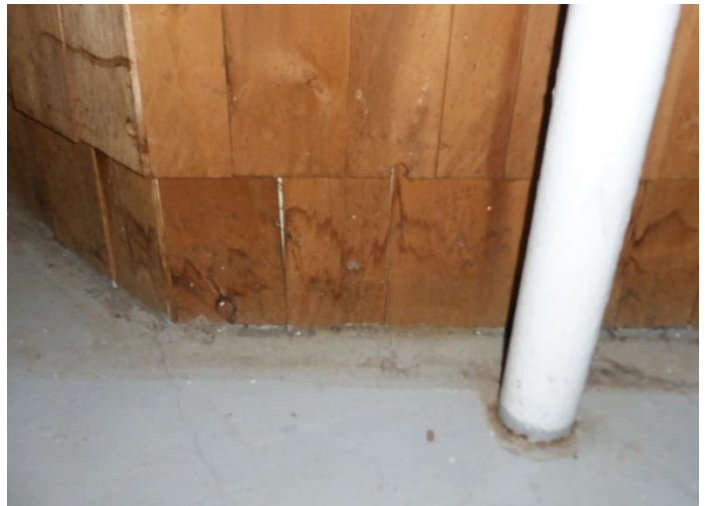
Water In Basement?<sup>3</sup> ----- Water stains were found at the bottom of the partition walls.

Water stains found on bottom of basement walls

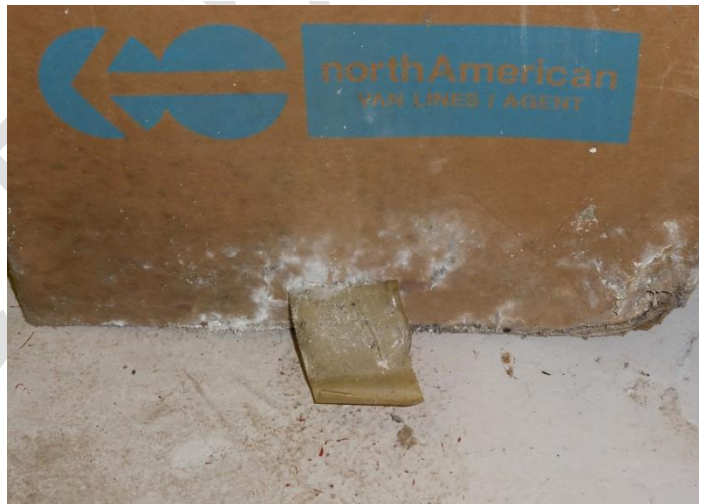
Suspect mold growth was observed in the basement.

Mold found on storage box in basement

Suspect mold growth was observed in the basement. Recommend using a dehumidifier set at a 50% relative humidity level in the basement. <http://www.epa.gov/iaq/molds/moldguide.html> <http://moldremovalnh.com/>  
<http://www.gordonmycologylab.com/>

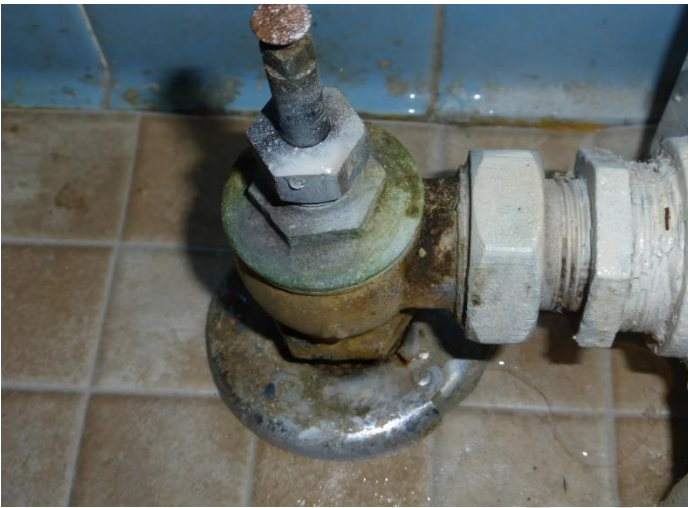
Water was dripping onto the 2<sup>nd</sup> floor bathroom floor

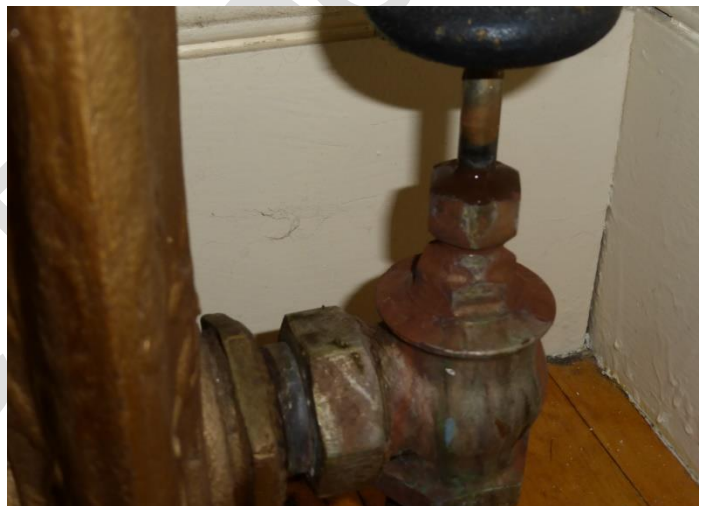
One of three leaky radiator valves

The leaky radiator valves need repair, valve handles are also needed.

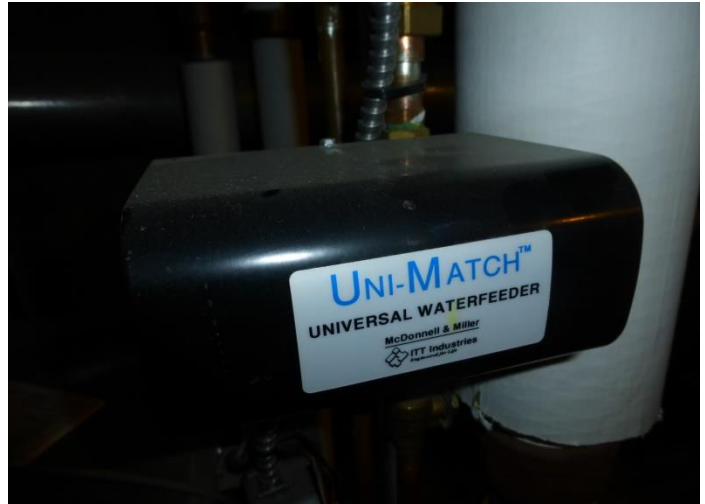
One of the boilers had an automatic water feed

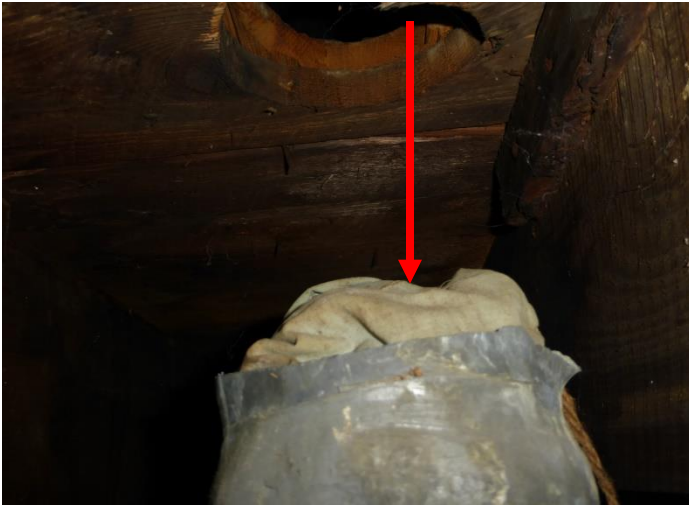
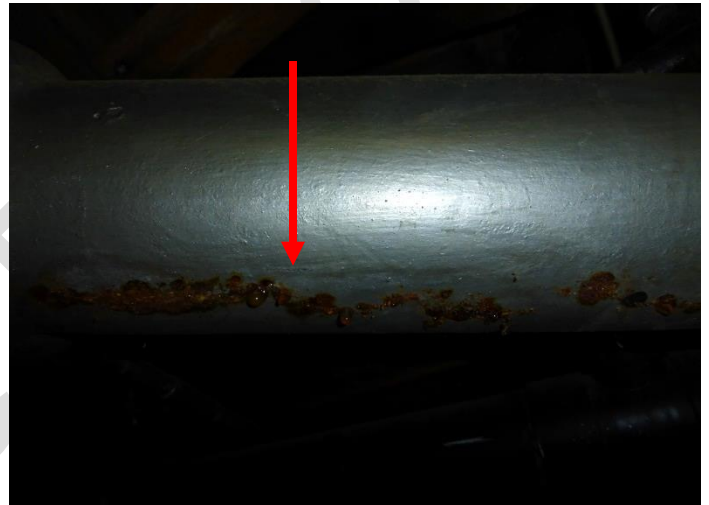
Minor leakage found at cast iron drain line section in basement

Water leakage found at a cast iron drain line section in the basement, replacement needed.

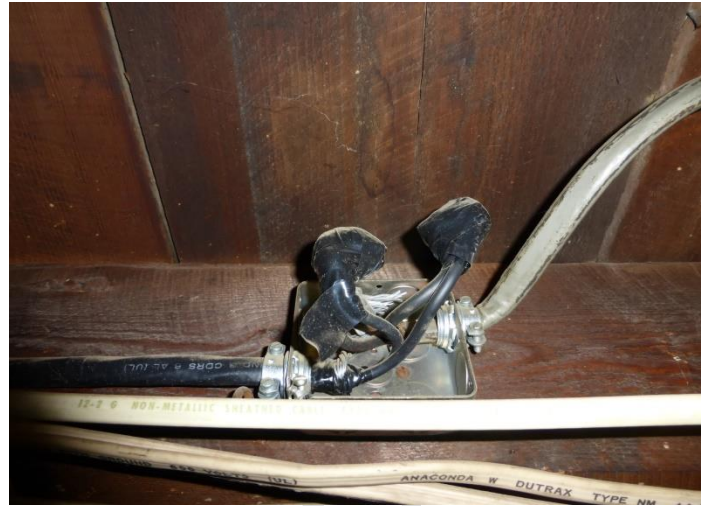
**Open electrical box in basement**

At least one open box enclosing wiring splices was observed in the basement (there may be others that were not visible at the time of the inspection). All wiring connections are required to be enclosed in approved boxes to reduce the risk of fire that could occur in the event of a fault that might cause sparking or overheating. This is a potential hazard that can be corrected by installing covers, however, in some cases larger boxes may need to be installed (this would require an electrician.)

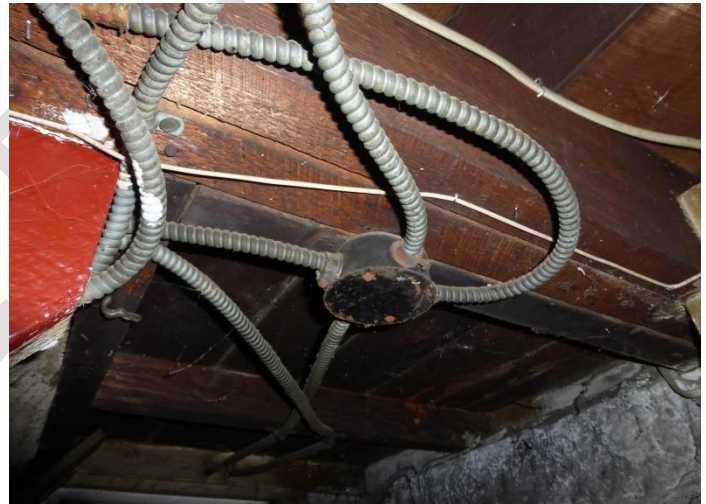
**Old armored cable**

Recommend having an electrician remove / replace all the original armored cable circuits still in use in the house. The wires within the cable are cloth insulated and deteriorate over time, especially at connections, such as light fixtures or wall switches. The cables at this home were over 50 years old.

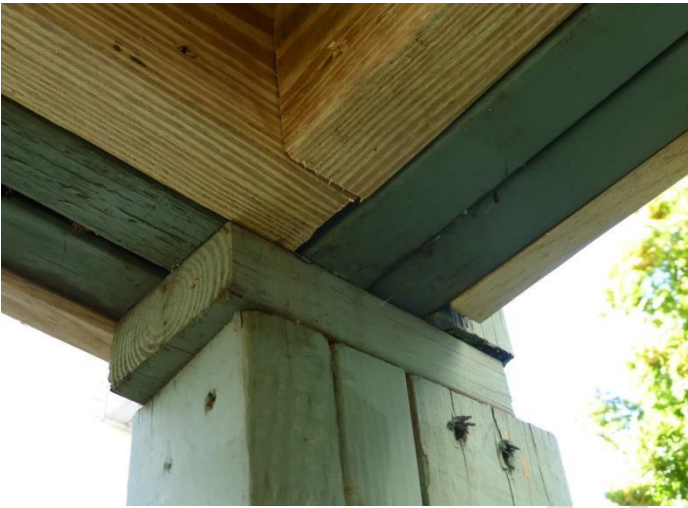
**Metal connectors lacking at side stairway / landing**

**FYI** – The side stairway and landing need repairs and reinforcements.

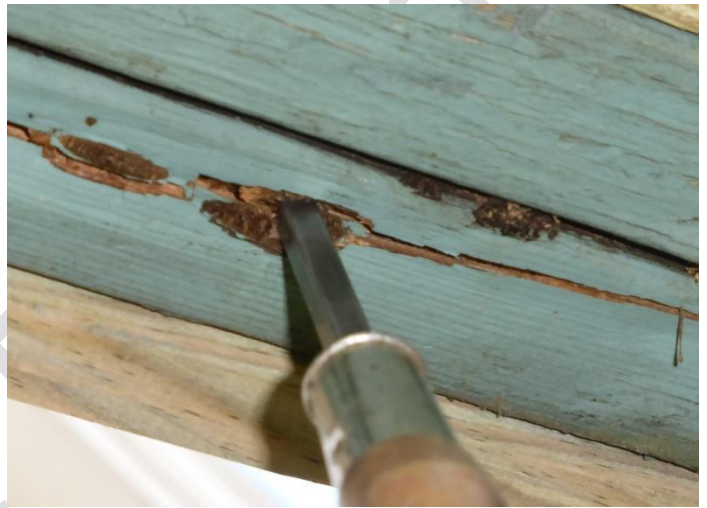
**Rotted wood at side stairway & landing**

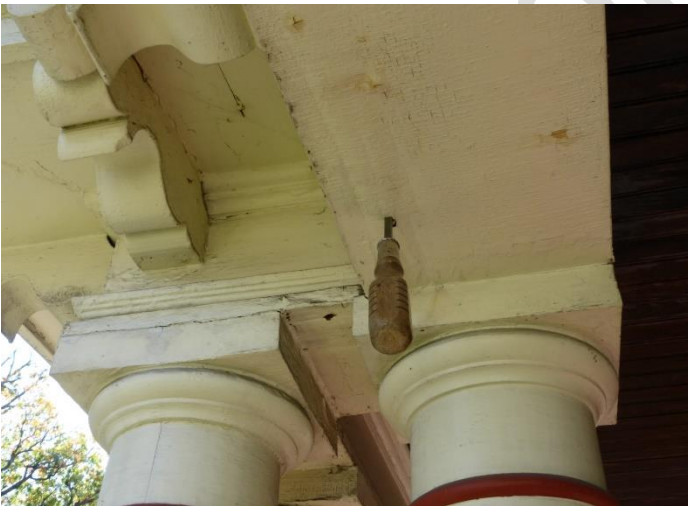
**Rotted wood at front porch roof structure**

The front and rear porch need repairs / replacements. The corner of the rear porch needs to have a proper support installed under it. The front porch needs replacements of the rotted wood roof structure.

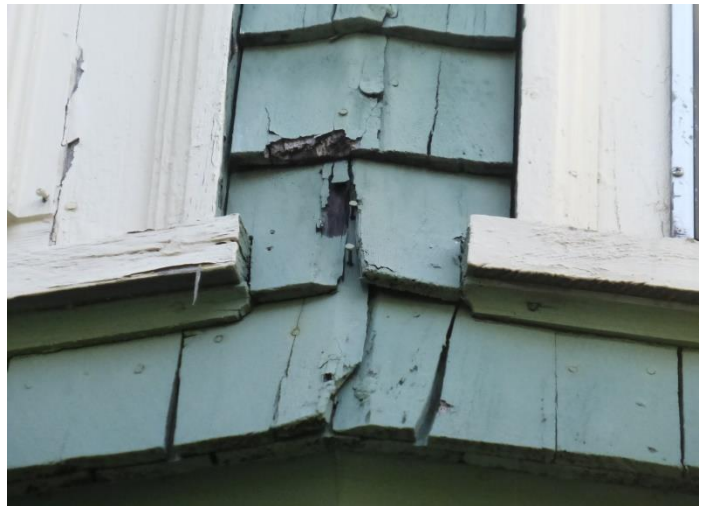
**Rotted wood at South side of house**

Numerous siding sections are in need of replacing.

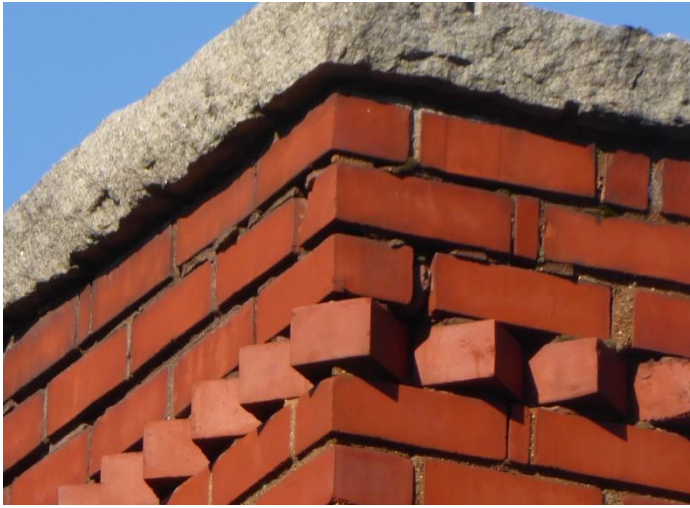
Chimney/s Exterior:----- Appeared functional except; Front left chimney was leaning slightly and some mortar was missing and dried out.

Loose / dried out mortar at front chimney

**FYI** - The mortar between the chimney bricks has deteriorated / eroded away from some of the joints. Repointing (cleaning out the joint and refilling with new mortar) is needed.

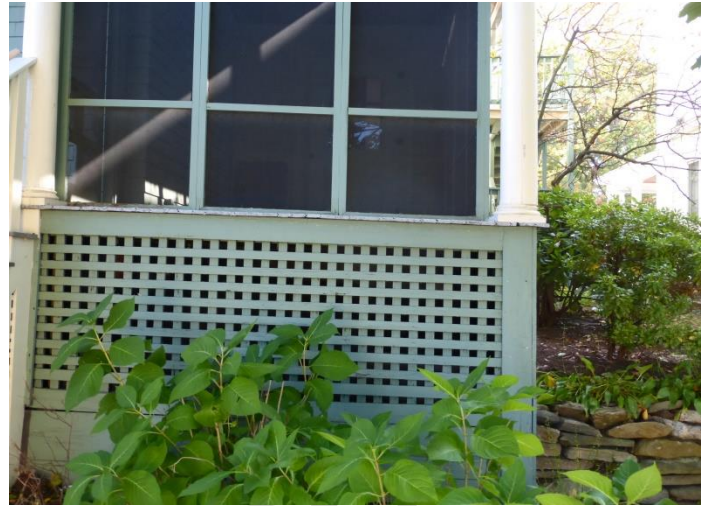
Porches: ----- Appeared functional except; Front porch: Some rot detected. Porch roof was sloped down to this rotted area. Rear porch: Corner area lacked proper support and deck was sloped down to this corner.

Rear porch was sloped down to the corner

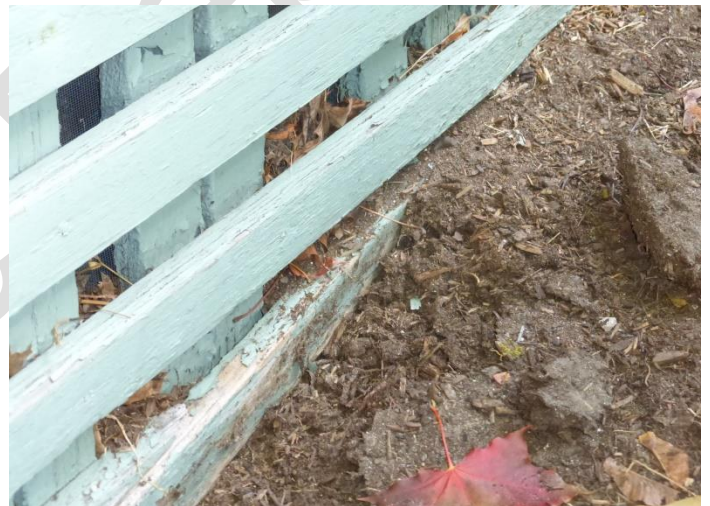
The bottom sections of the porch wood trim are in ground contact, this will result in rot and / or insect damage.

Termite risk at rear porch trim

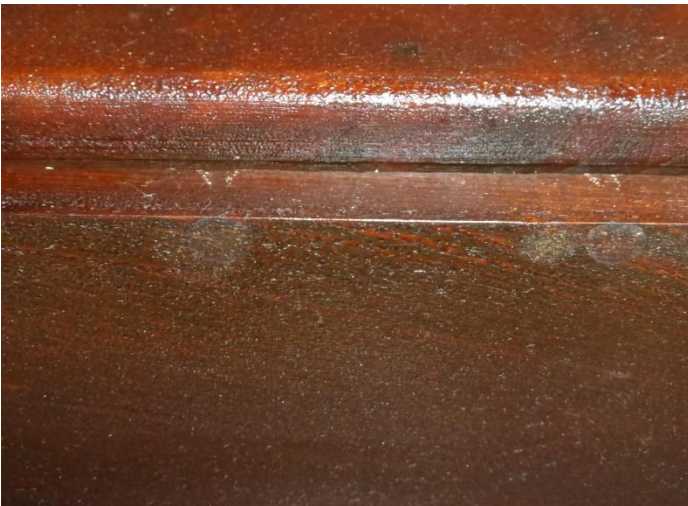
Cap / head flashing was painted over, but it did appear deteriorated and did not fully cover the window trim, some wood rot was found under the paint

**Investigate Further** - There were some water stains found at the upper casing trim sections of a couple or more windows on the 1<sup>st</sup> floor, one to the right of the fireplace and a couple in the dining room. The exact cause / source of the stains was not determined, however, the cap / head flashing above the exterior of these windows is suspect.

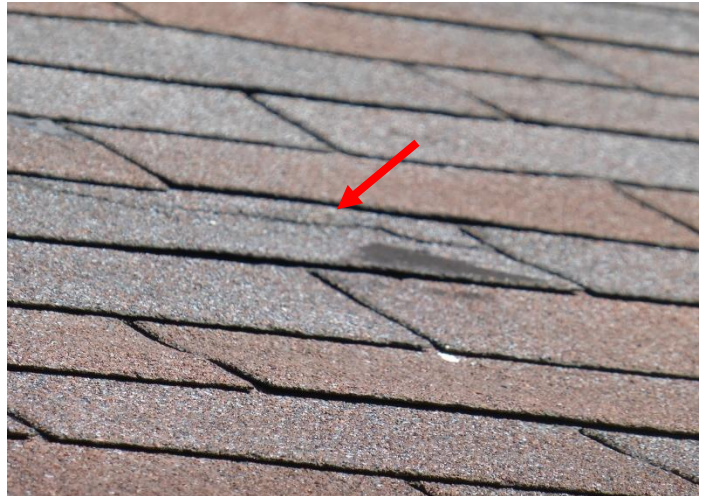
Several split / cracked shingles were observed

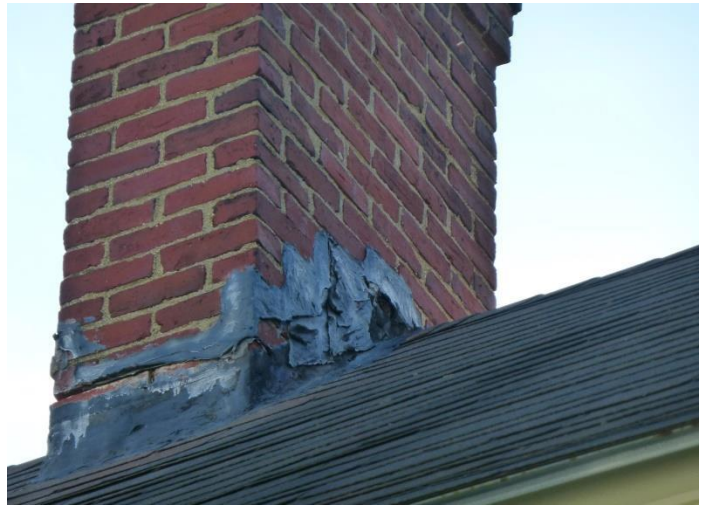
**Flashing at rear chimney was damaged**

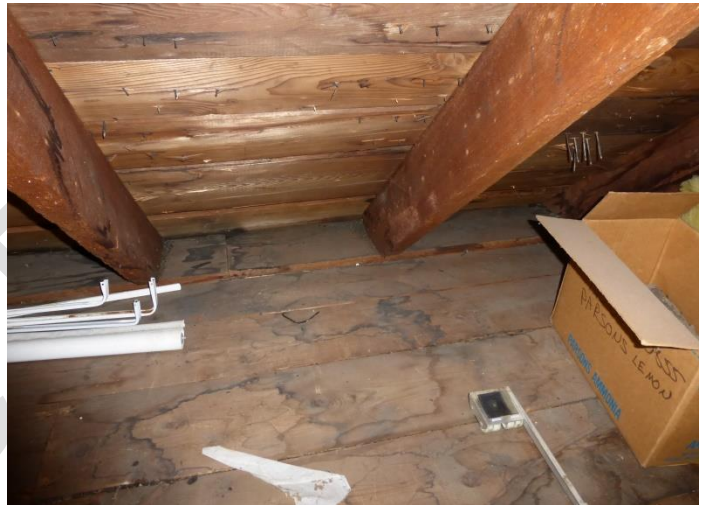
**Numerous water stains found at attic floor**

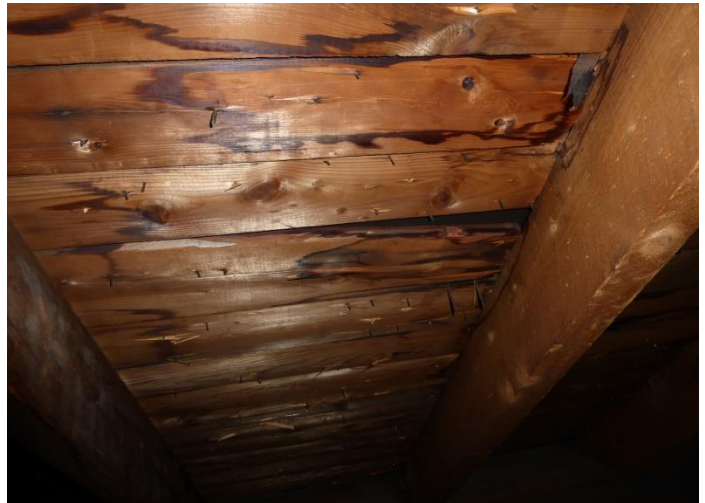
The water stains on the lower portions of the roof rafters and roof sheathing were likely caused by past ice dam related leakage. Asphalt roof shingles are not water tight, but design to shed water. If ice and snow build up on the lower portions of the roof surface and subsequent melting of snow on the upper portions of the roof runs down into this "ice dam", water can back up under the roof shingles and into the attic or walls of the house. There is a water tight membrane referred to as "ice and water shield" that most roofers today will install to the lower 6 feet of the roof sheathing and other high risk areas such as valleys, (all existing roof shingles need to be removed before this can be done.) Ice dams can also be minimized by adequate attic ventilation.

**Numerous water stains found on roof sheathing**

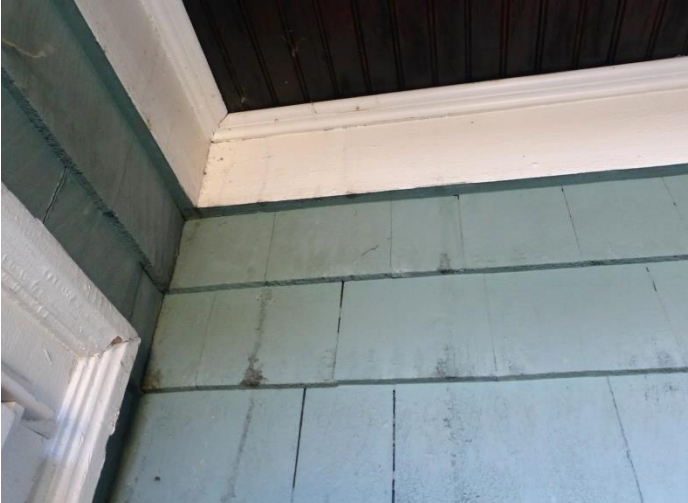
Water leakage evidence between porch roof and house wall found

The rear porch roof shingles need to be replaced with a metal or rubber membrane covering. Flashing repair between the porch roof and house wall also needed.

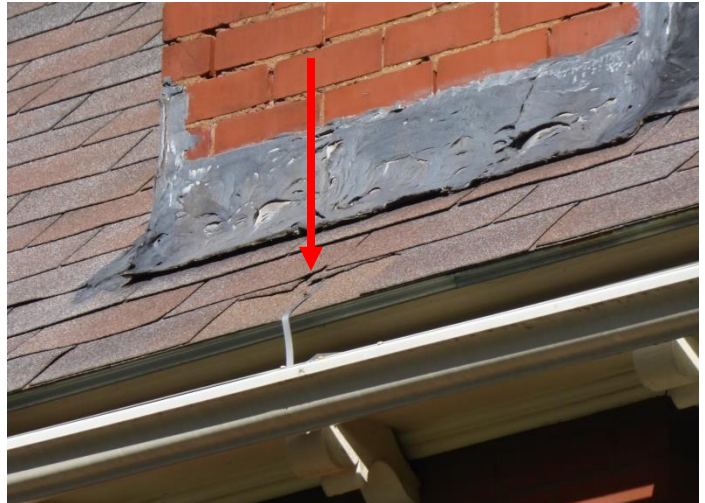
Missing shingle at gutter strap

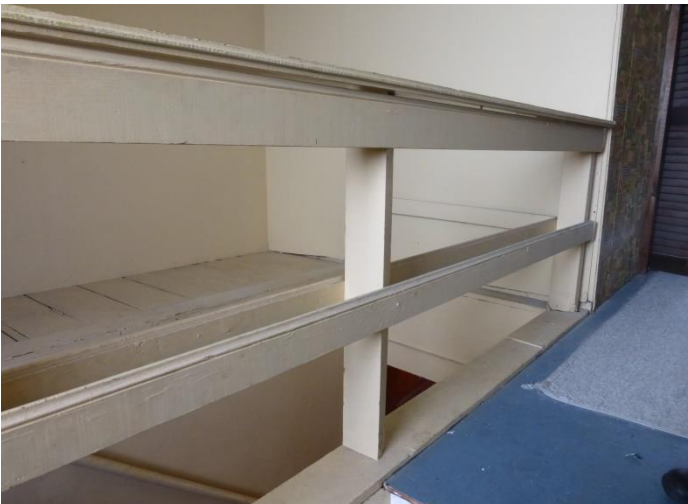
**Safety Concern** - The attic stairwell guardrails allow a space or opening between them greater than what today's safety standards call for. The specifications or standards that are followed today are as follows: Required guardrails on open sides of stairways, balconies, porches, decks and raised floor areas shall have intermediate rails, balusters or ornamental closures which prevent the passage of an object four inches (102 mm) or more in diameter. Exception: Triangular spaces formed by the riser, tread and bottom rail of a guard at the open side of a stairway may be of sized to prevent the passage of a sphere six inches (153 mm) in diameter.
