# Home / Building Inspection Report

Report prepared for: John Doe  
Property address: 123 Main St, Somewhere, NH.  
Date of Inspection: 10/09/2014  
On site start time of inspection: 10:00 A.M.  
On site finish time of inspection: 1:20 P.M.  
Approx. year building constructed: 1910.  
Property type: Two family, wood framed.

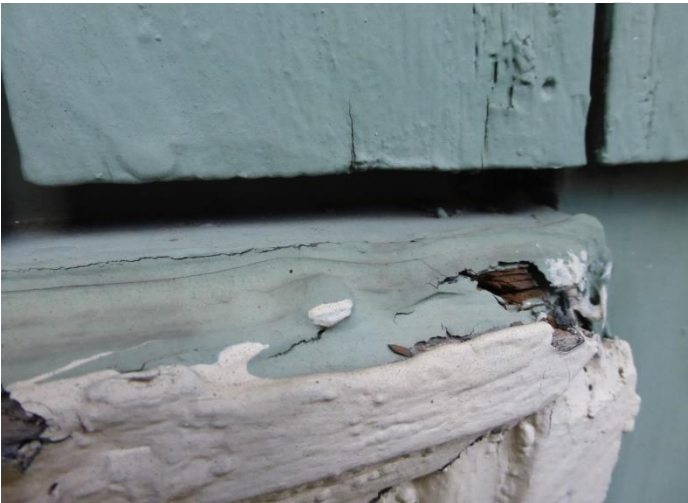
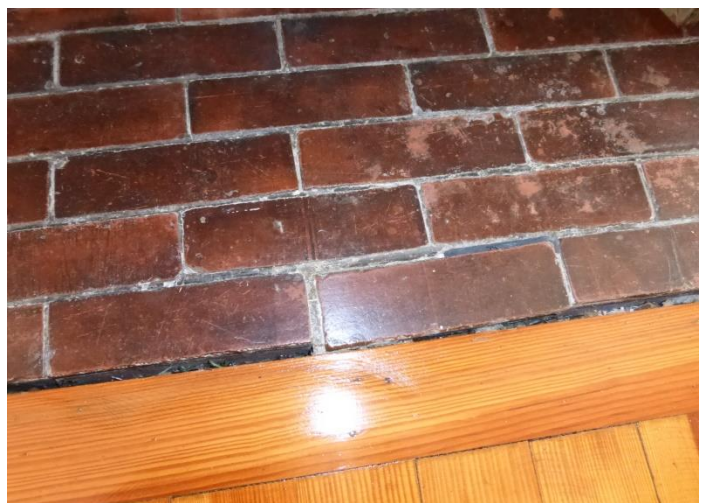
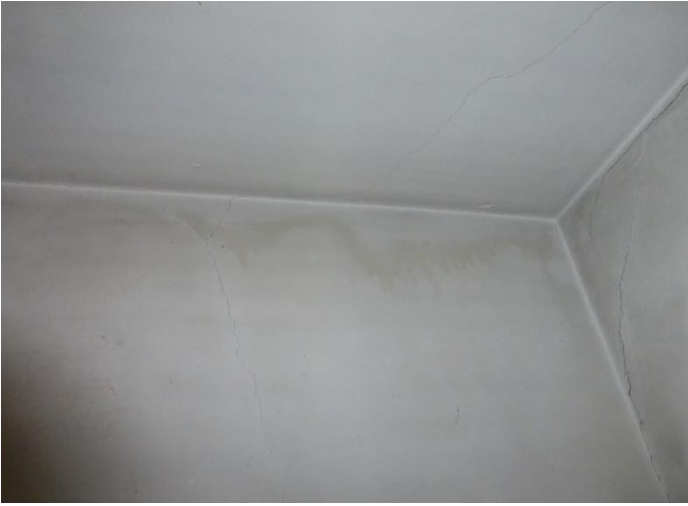
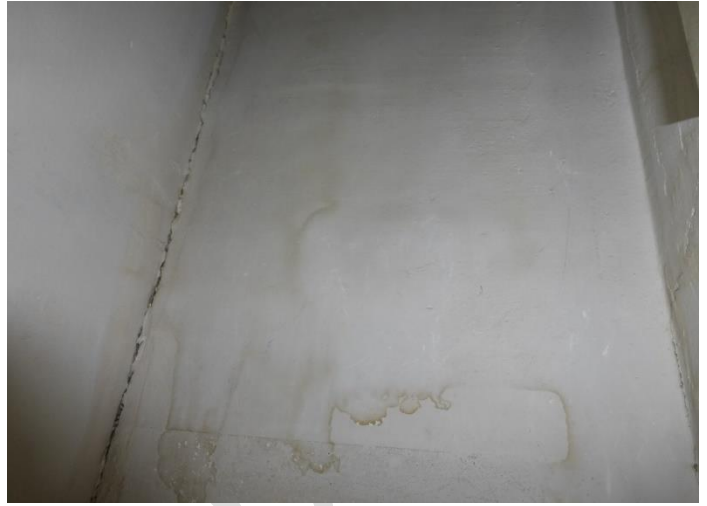
Gap between floor and hearth bricks

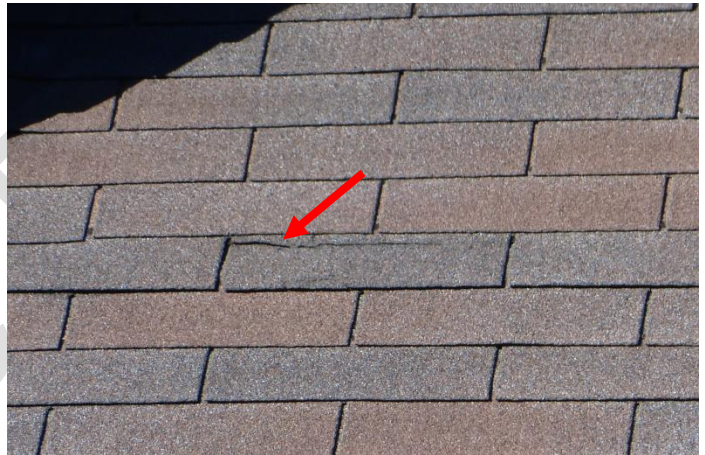
Roof structure replacements are needed at the garage.

Asphalt fiberglass based roof shingles manufactured prior to 1992 have had a track history of failures. The problems include shingles that split, crack, tear, rip or get blown off the roof. The failures are not limited to any one brand. Typically the symptoms showed up two to five years after the shingles were installed. Fiberglass based shingles unlike organic based ones are only coated with asphalt flux and not saturated with it. This may be one of the reasons for the higher rate of failures. Fiberglass based shingles also have a lower "nail pull resistance" than organic based shingles and are more prone to nail popping. The current

specifications for manufacturing fiberglass based shingles have been changed to improve the performance of the product, but we have found that fiberglass based shingles still tend to tear more so than organic based shingles. It is recommended that the roof surface be inspected closely after any storm that has strong winds. Several shingle repairs / replacements are needed at the present time.
